SPECIAL REPORT ON ANADROMOUS STREAM SURVEYS OF CLEVELAND
PENINSULA, INCLUDING EMERALD BAY, VIXEN INLET, UNION BAY,
CLARENCE STRAIT, BOND BAY, SPACIOUS BAY, AND PORTIONS OF
PORT STEWART AND HELM BAY

Subdistricts 107-10 and 102-80

March 1985

Alaska Department of Fish and Game
Division of Commercial Fisheries
Petersburg, Alaska

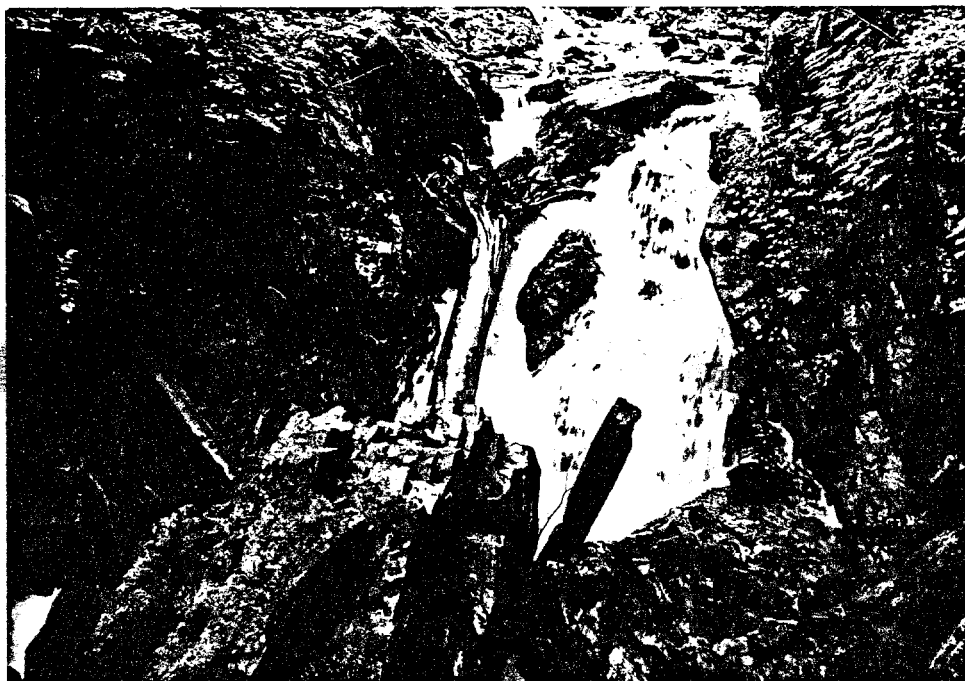
7. Section 7: Probable 4 m. stairstep falls 150 m. beyond Section 50.

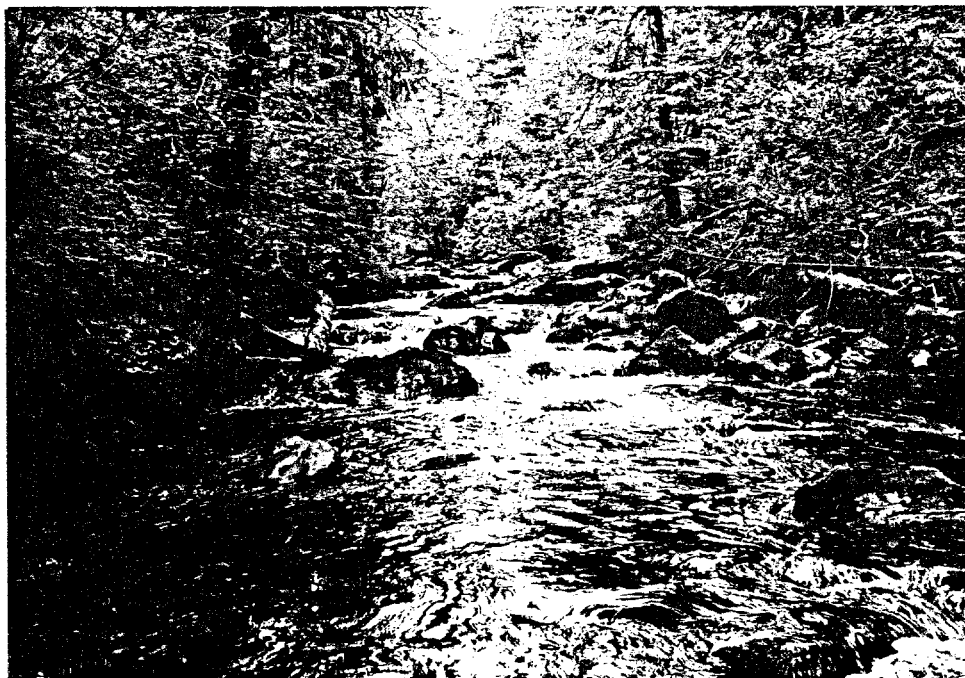
8. Large boulder and bedrock substrate 400 m. beyond Section 50.

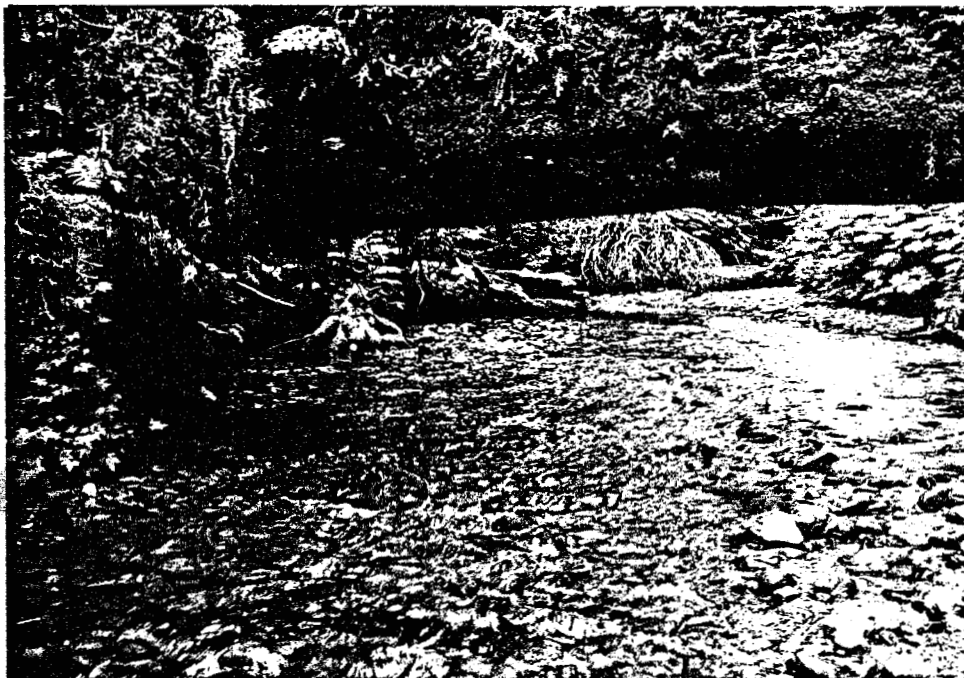
1. Section 2: Typical large cobble substrate in the ASA of the lower reach.

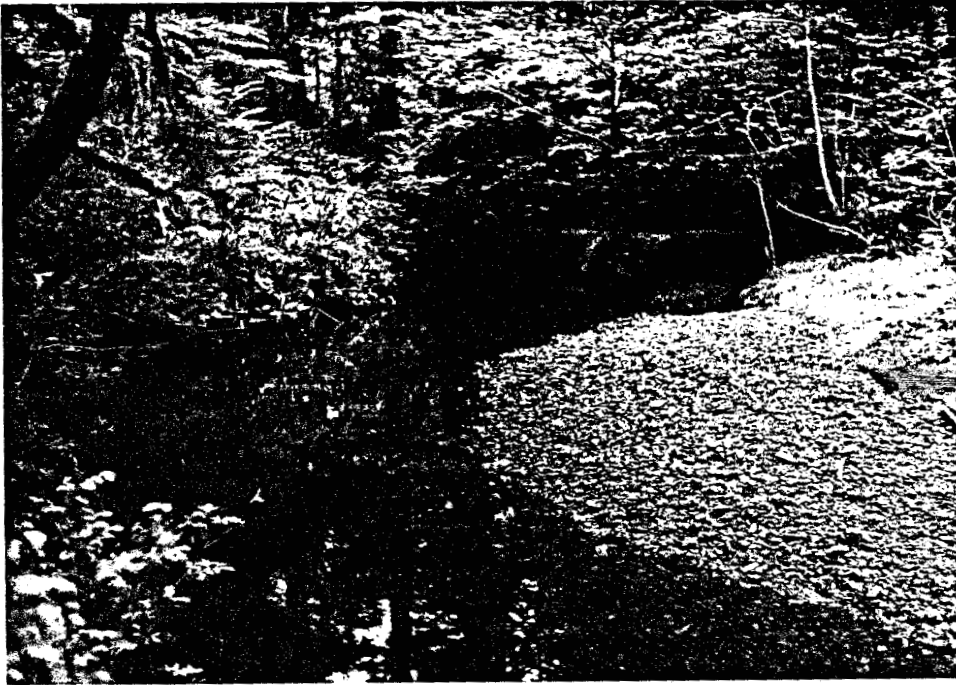
1. Section 1. Excellent rearing.

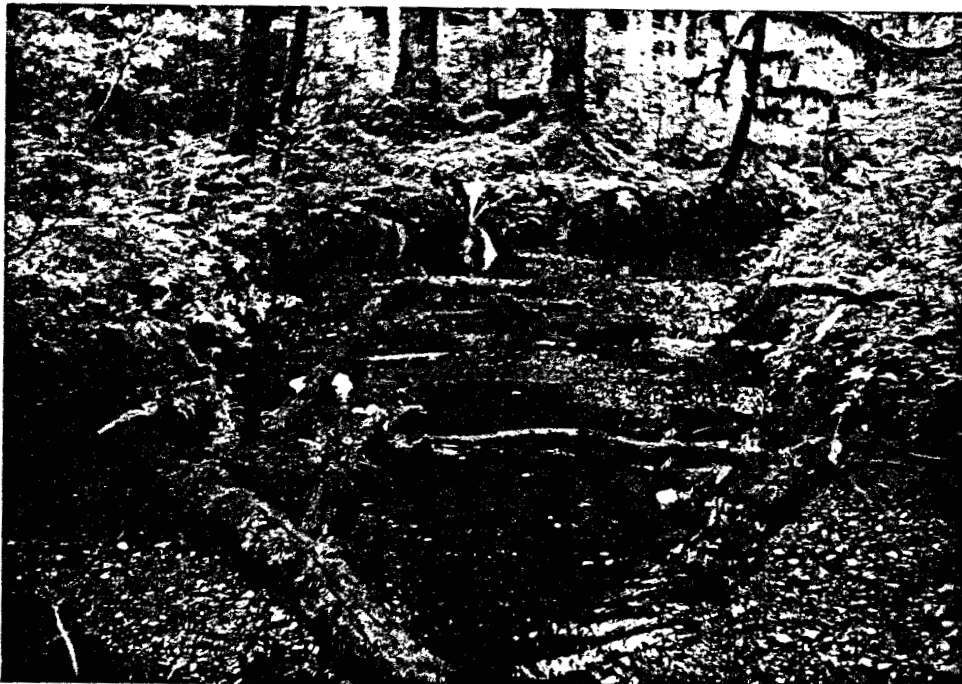
2. Section 2. Good riffle area.

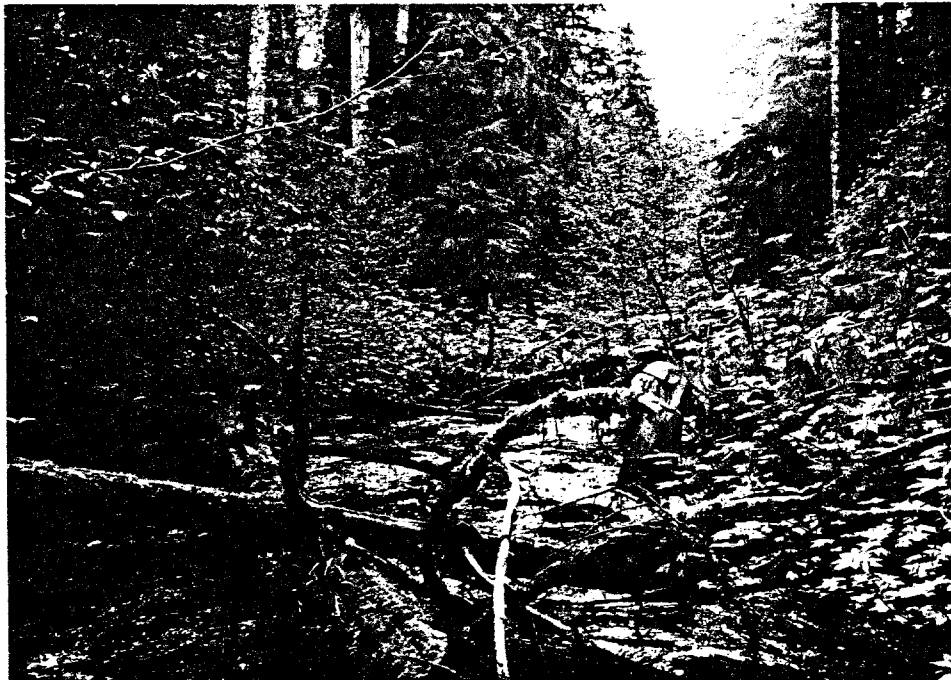
2. Typical habitat in Section 4.

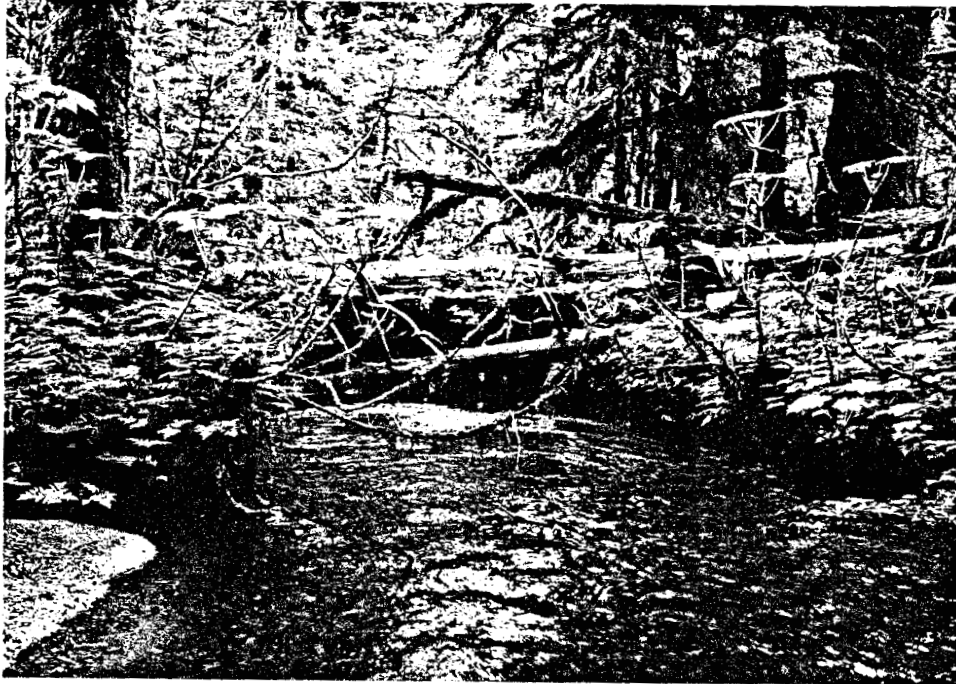
3. Excellent ASA in tributary above beaver dam.

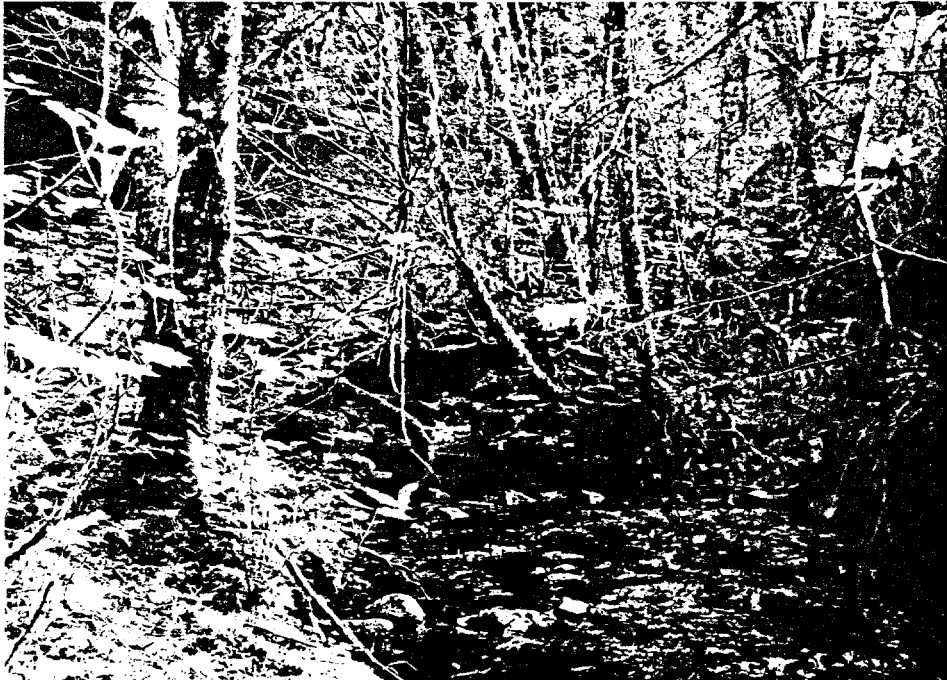
2. Section 2: End of accessible ASA.

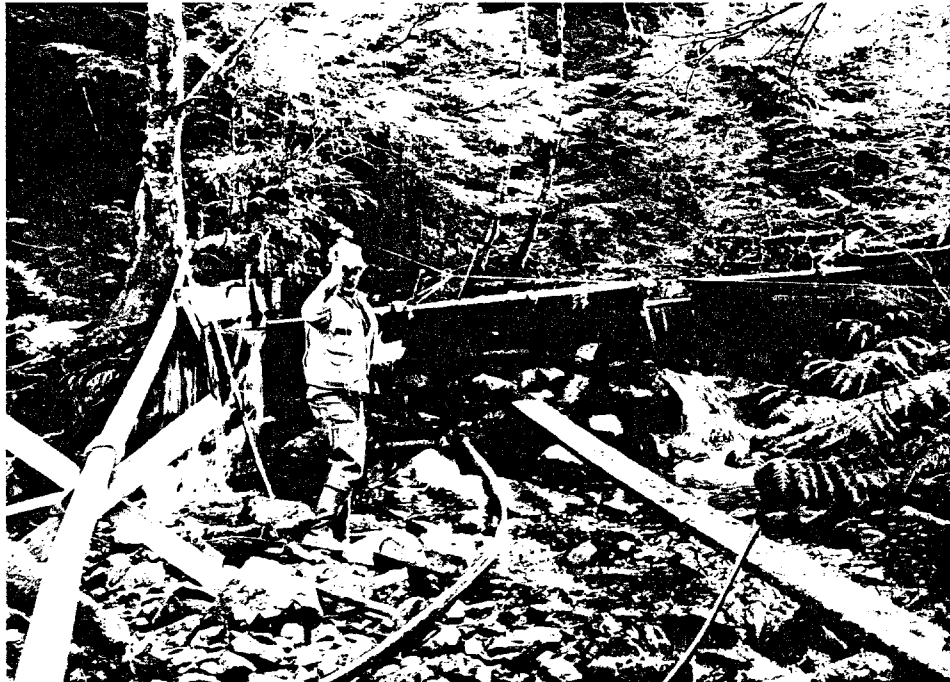
4. Section 3: Manmade barrier.

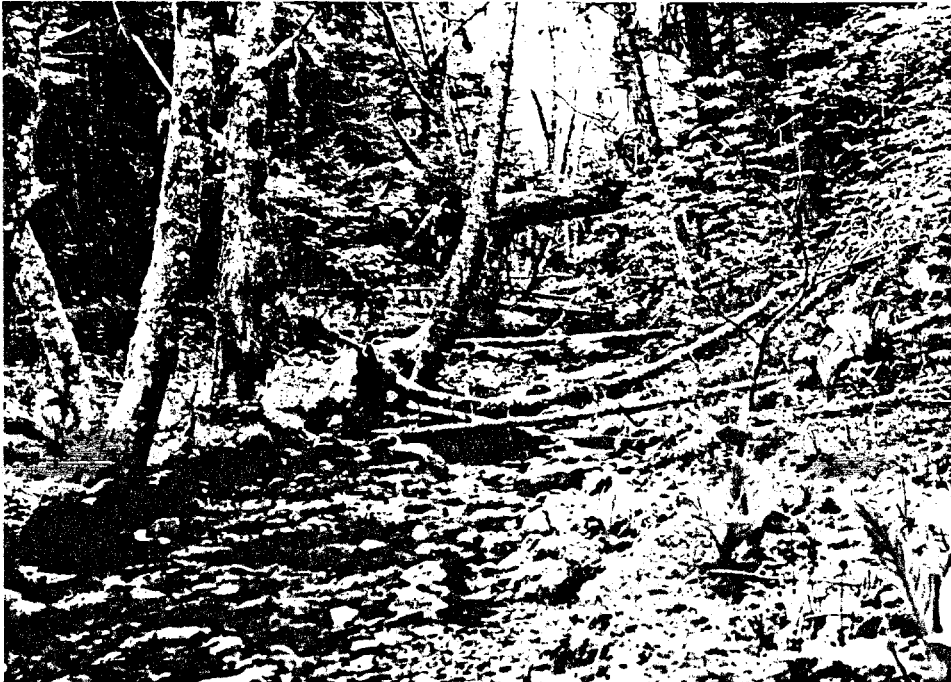
1. Typical habitat in Section 1.

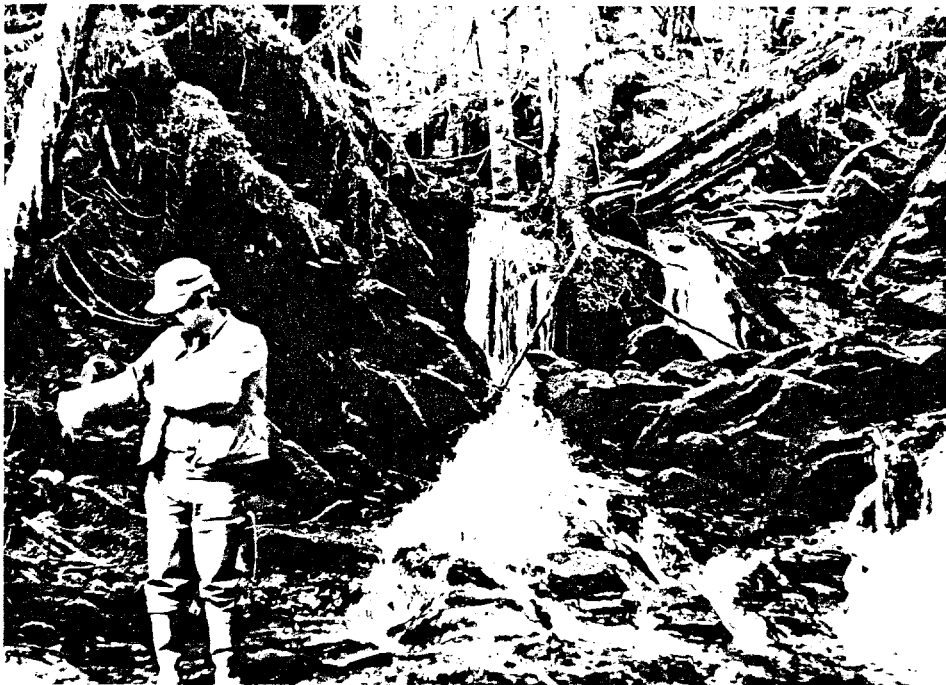
2. Three meter falls near the end of Section 2.

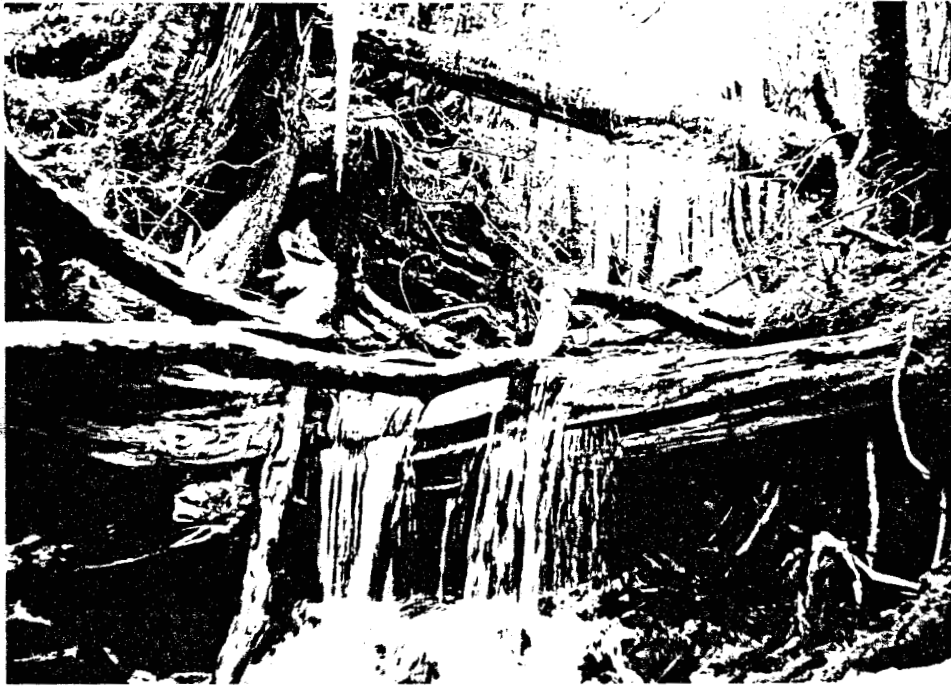
3. Section 7: Typical habitat in upper reach.

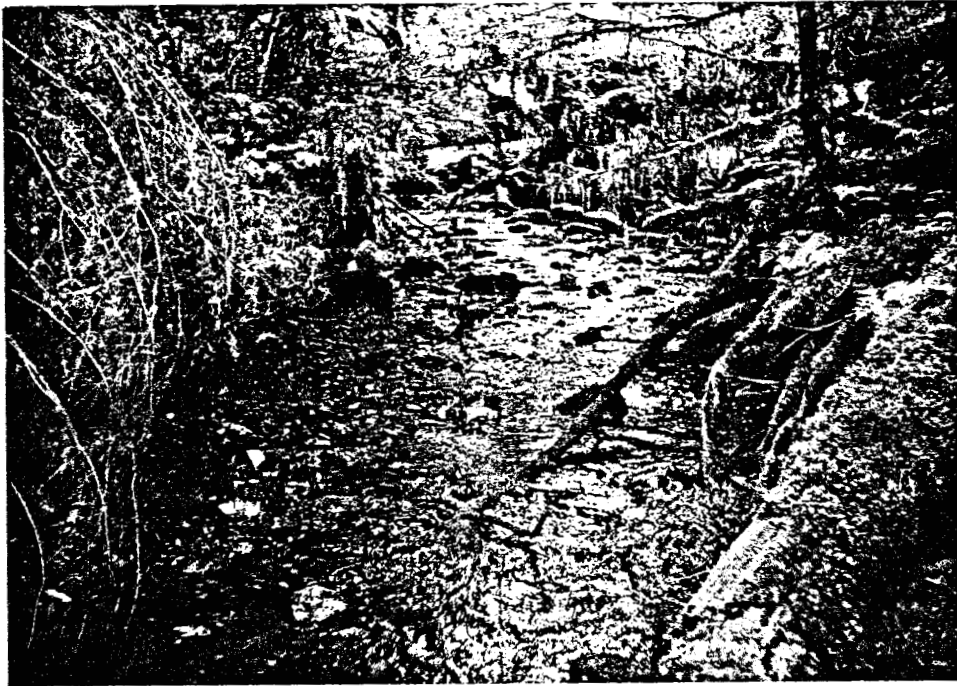
3. Good riffle and ASA in Section #4

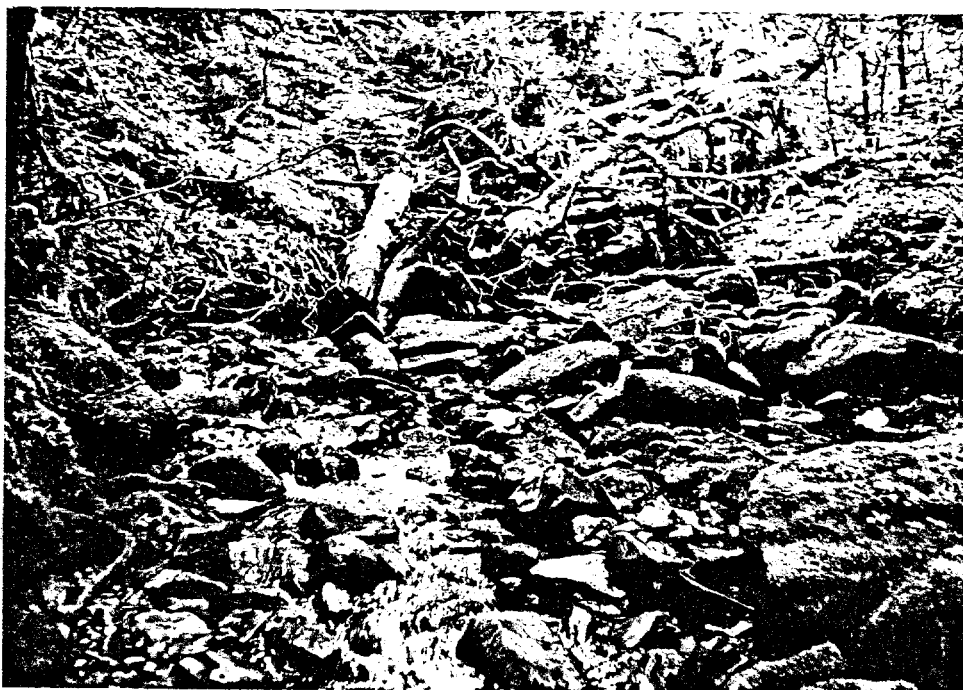
2. Section #1

Section 1: PS bones were observed on the upper bank. Rearing coho were observed with regularity, but in low density. The substrate is large and the ASA is only fair quality. Section 1 has few riffles, but many pool areas.

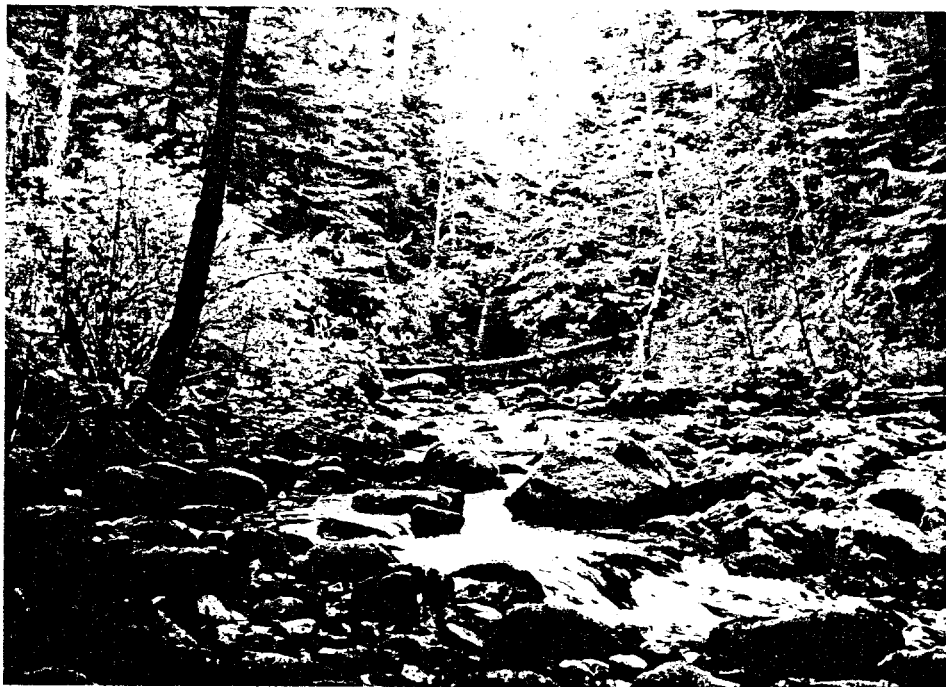
2. Section 1: Poor habitat typical of lower reach.

Section 1: Five rearing coho observed. The substrate is predominately boulders and little ASA is provided. The rearing habitat is limited by the lack of cover even though rearing coho were observed throughout the survey.

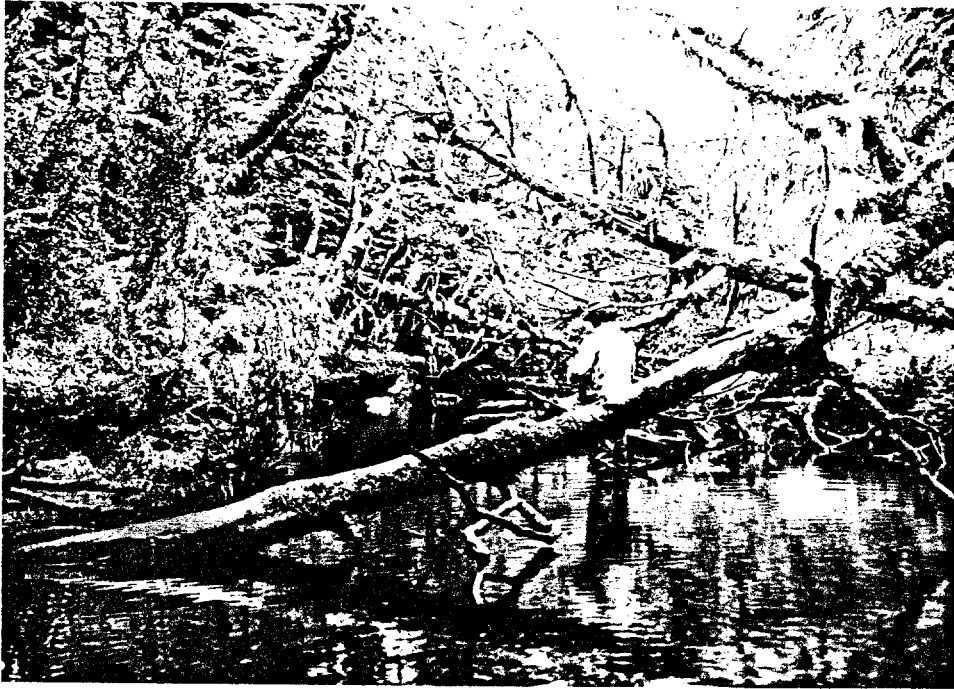
3. Rearing habitat in Section 7.

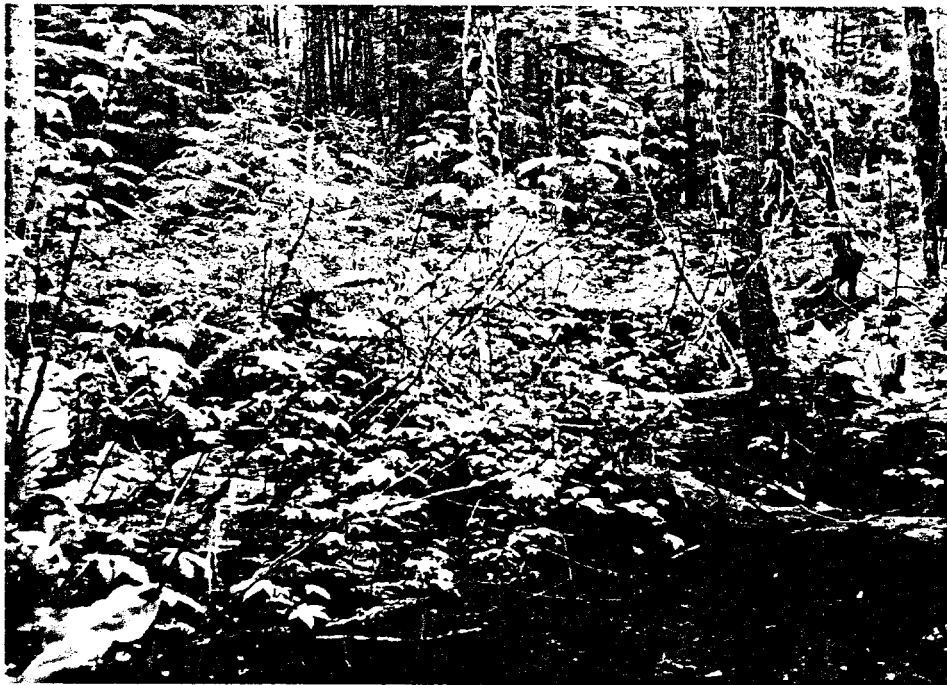
4. Tributary in Section 21.

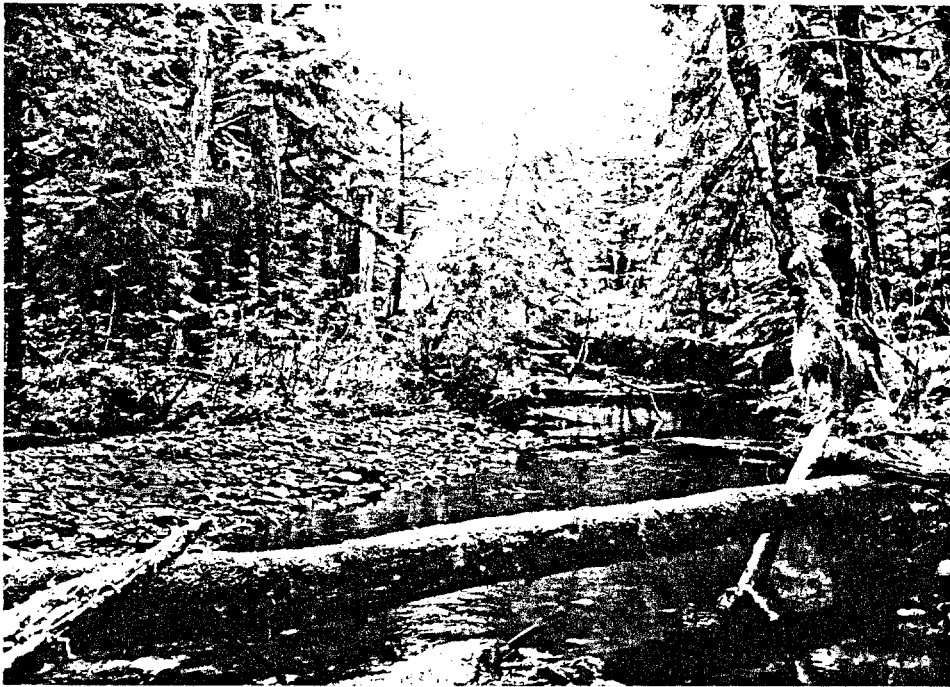
5. Large substrate at end of survey.

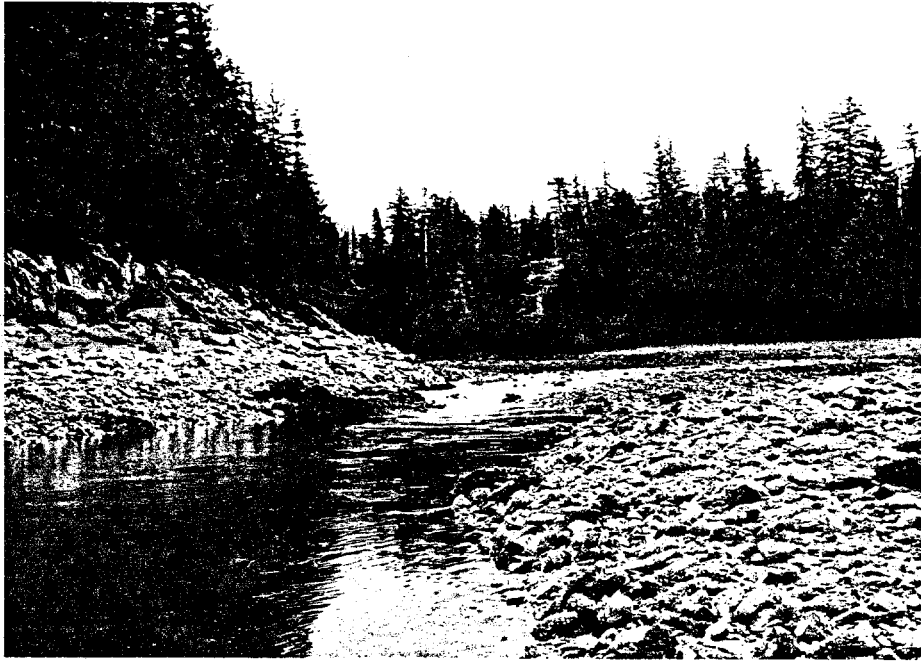
1. Schooling area in lower ITZ.

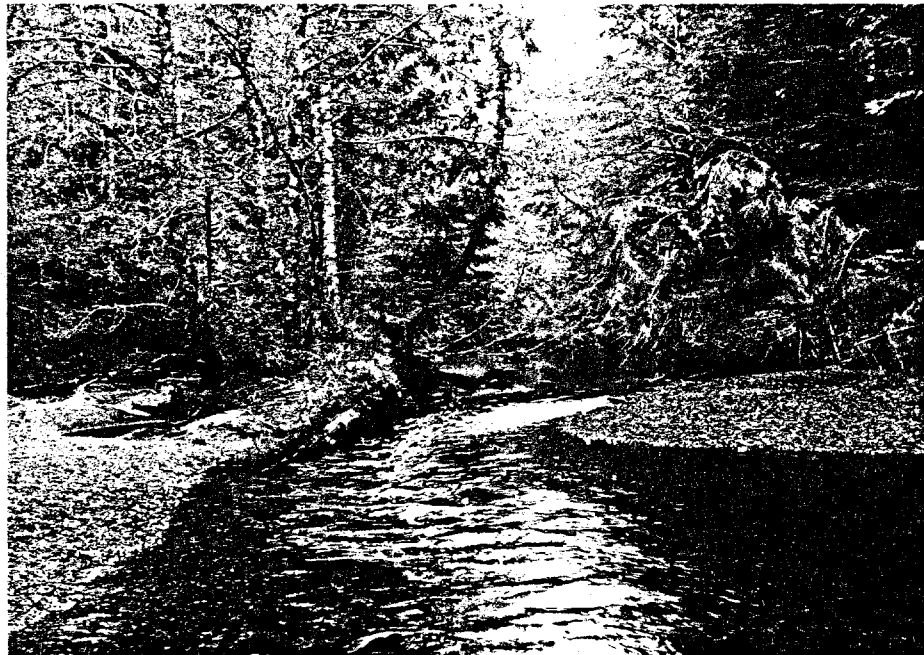
4. Excellent ASA near the end of Section 14.

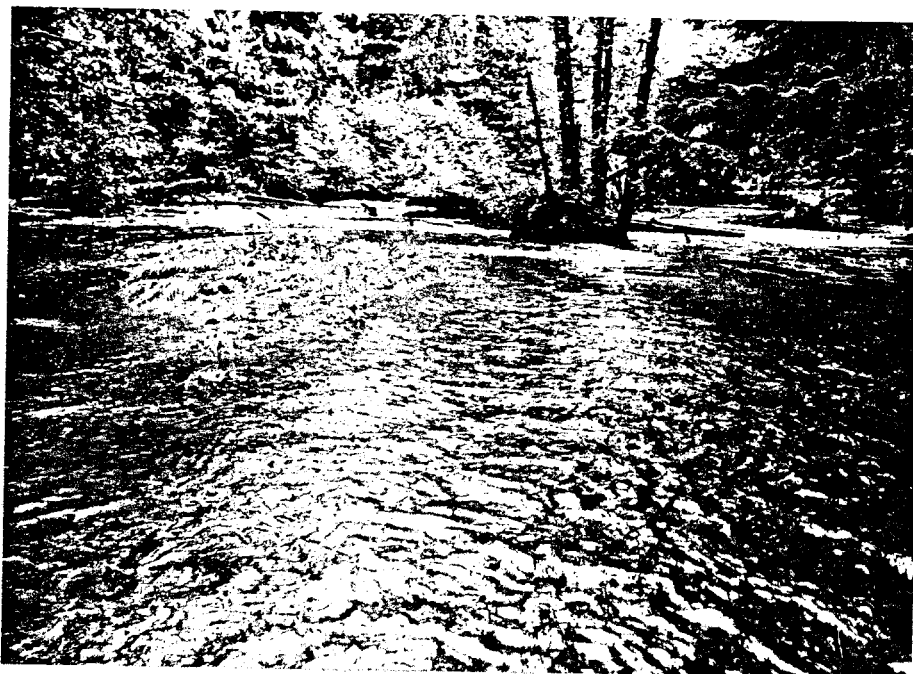
5. Section 20. Good riffle area.

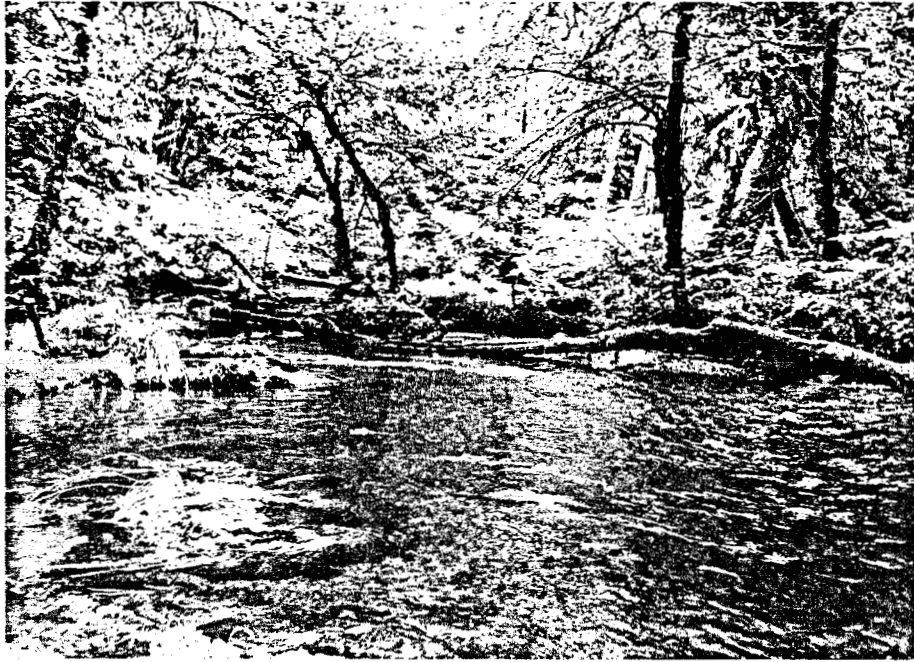
7. Section 24 - Tributary entering from the right bank.

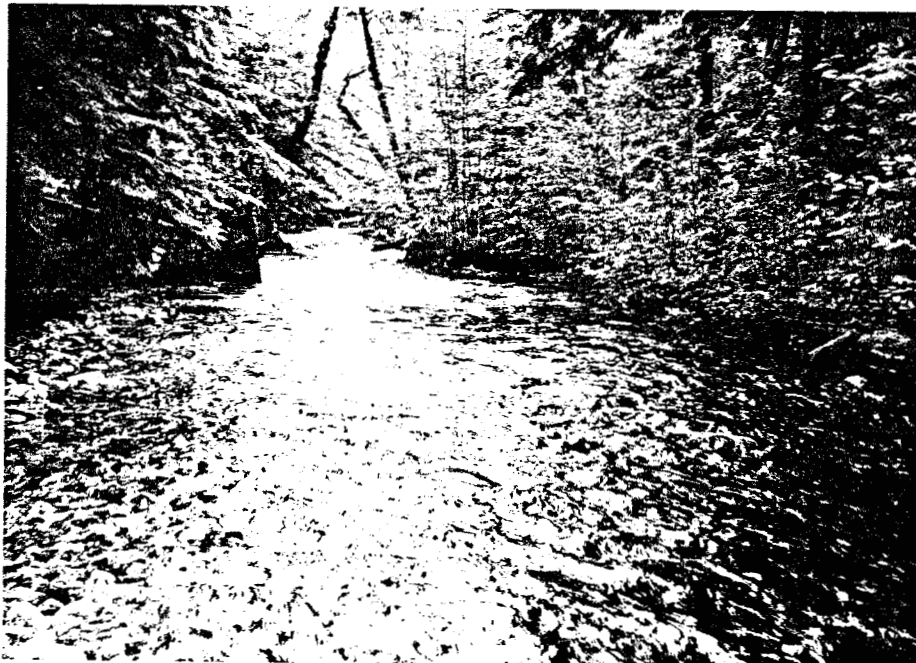
8. Section 29 - Gradient begins to increase with a higher percentage of boulder.

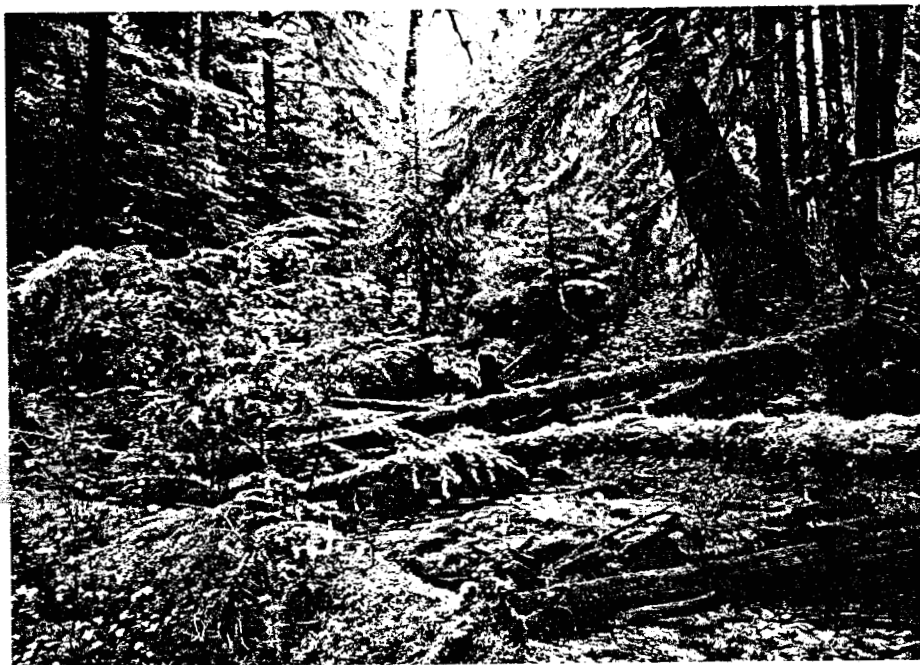
1. Braided area confluence of Area A and Area B.

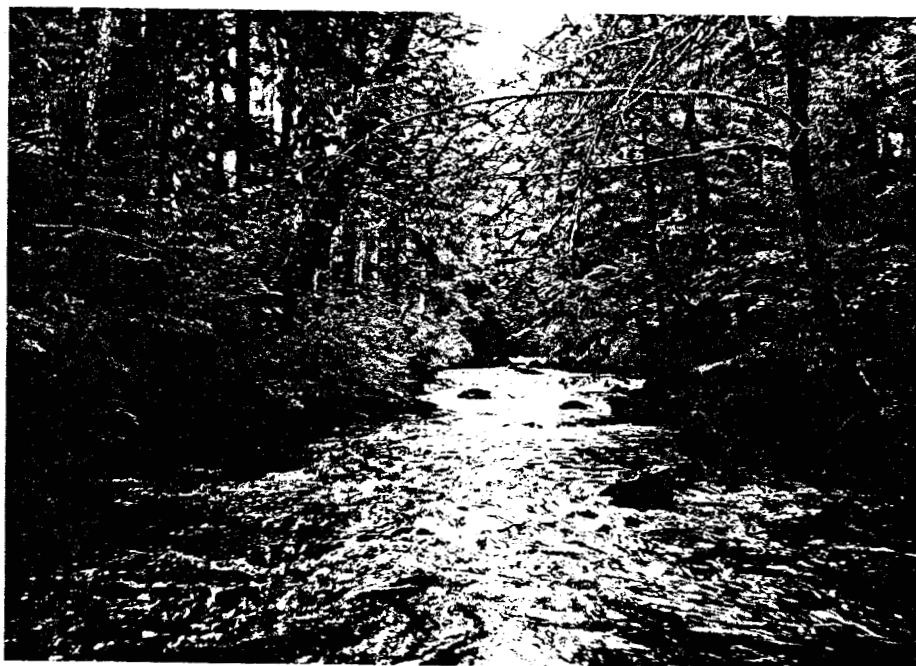
2. Boulder/bedrock substrate in Section 8.

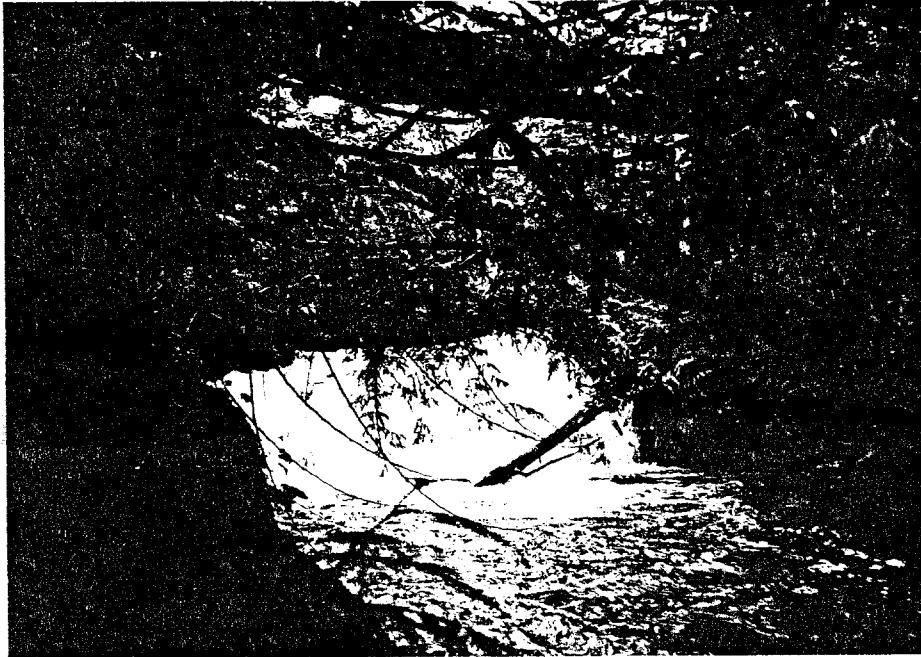
3. Probable velocity barrier in Section 9.

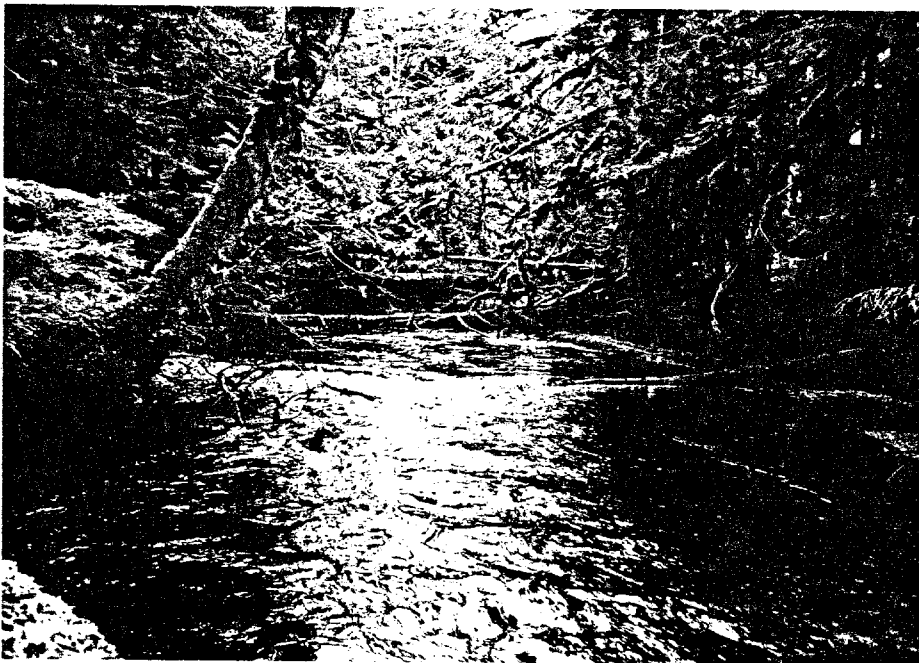
4. Good ASA in area above end of survey.

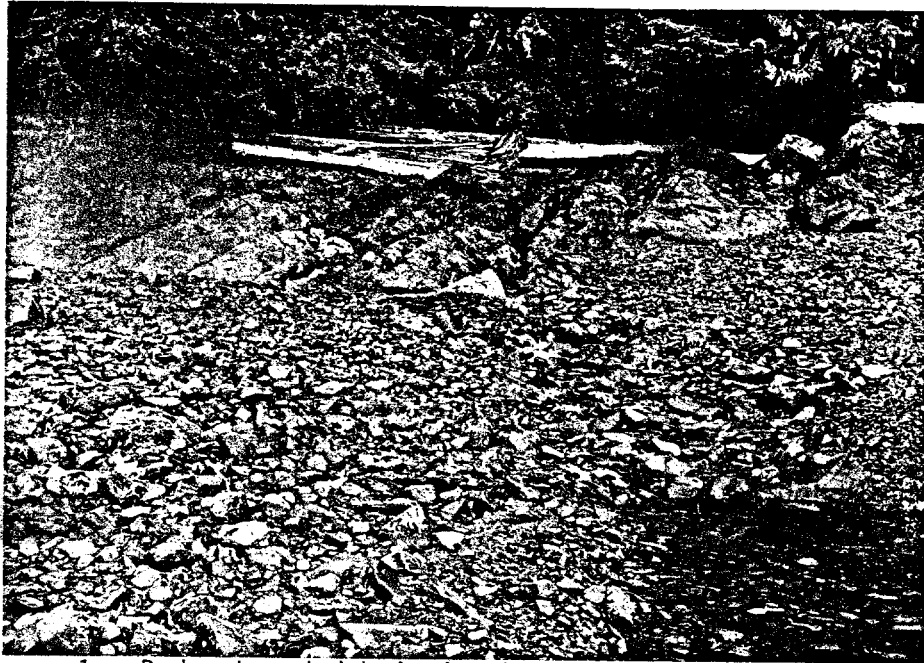
1. Bedrock and debris in the upper ITZ.

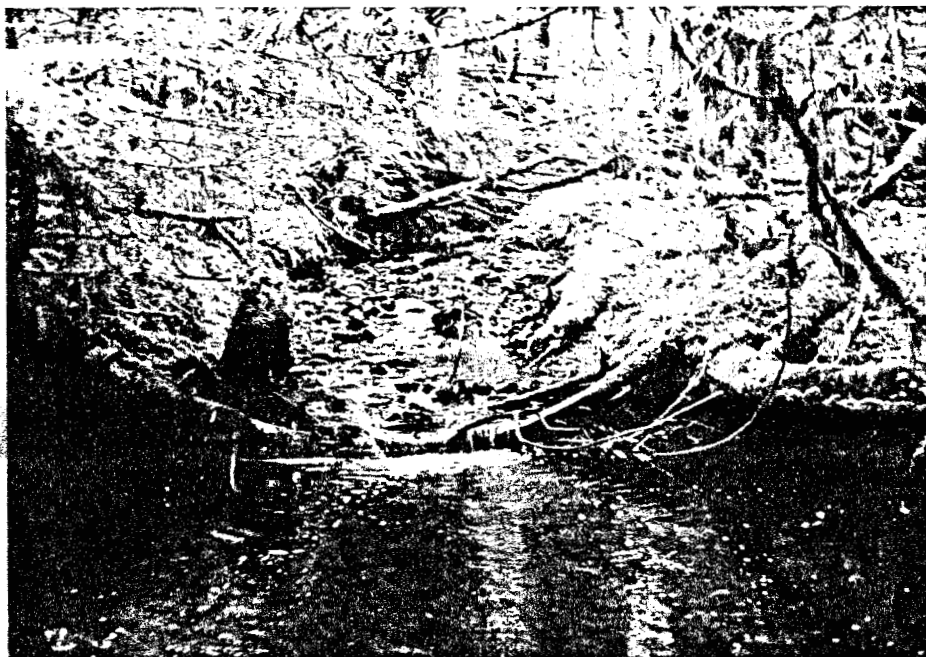
3. Typical habitat in Section 1.

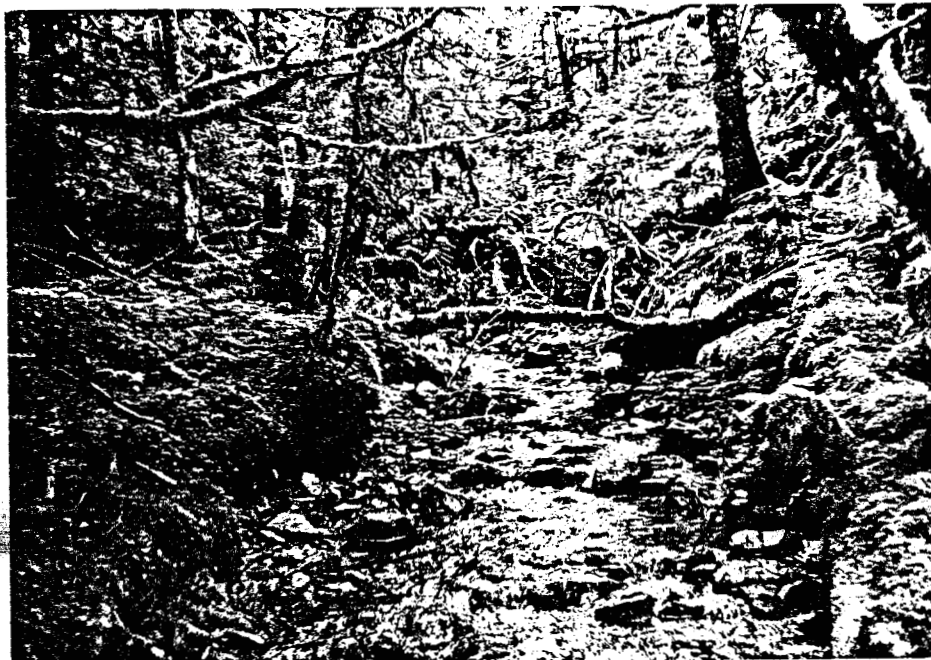
1. Section 1: Poor ASA and rearing habitat.

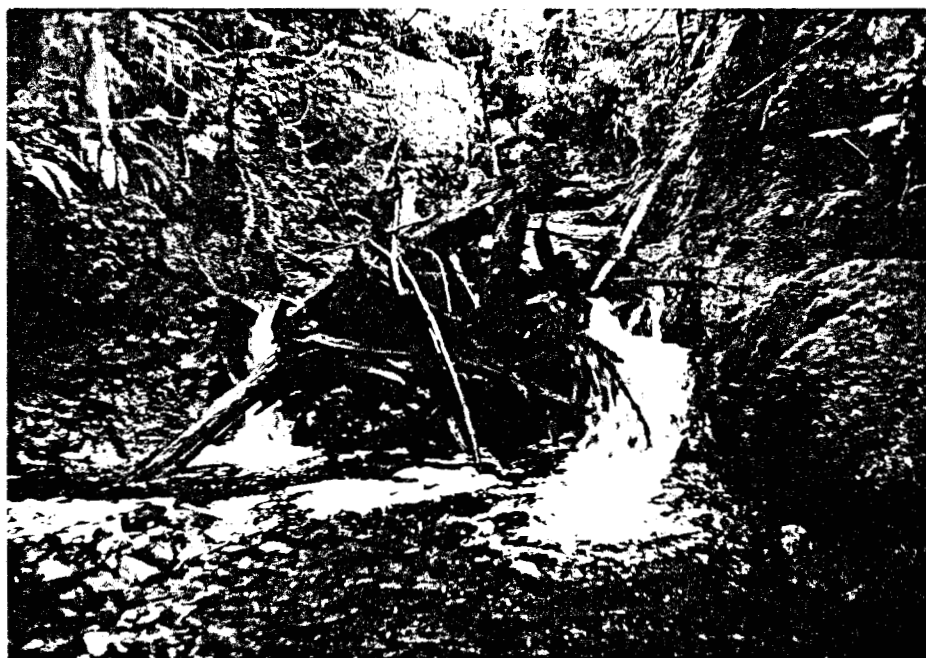
2. Potential debris barrier near the end of Section 1.

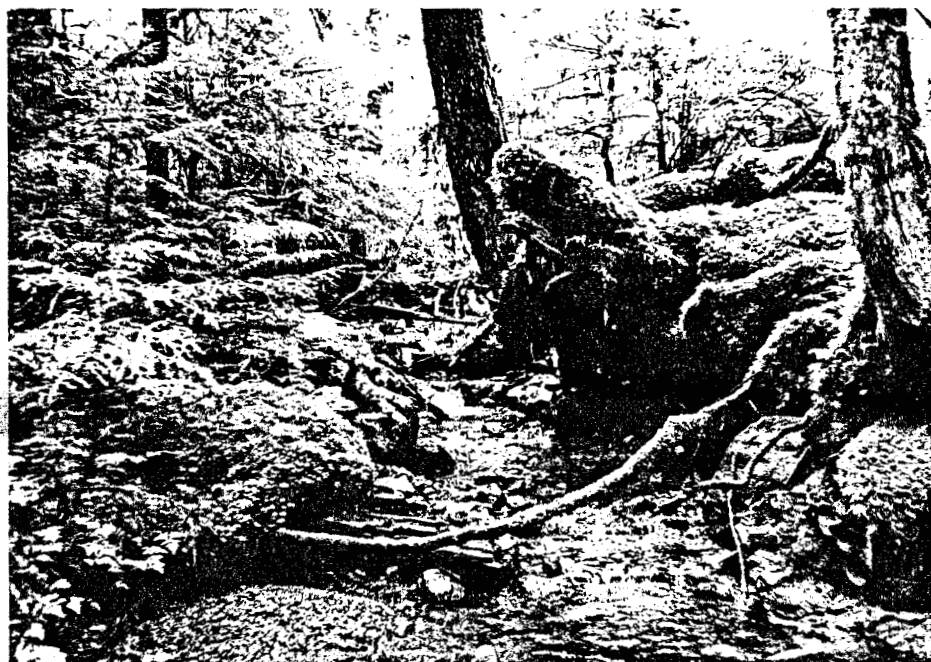
3. Section 7: Typical habitat in upper reach.

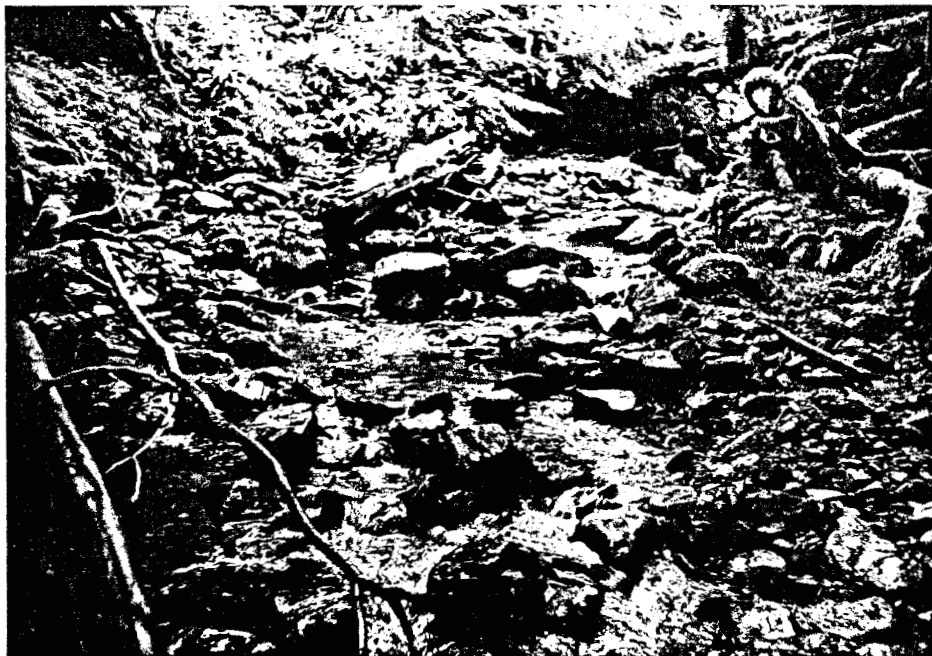
2. Section 1: The substrate is predominately boulders.

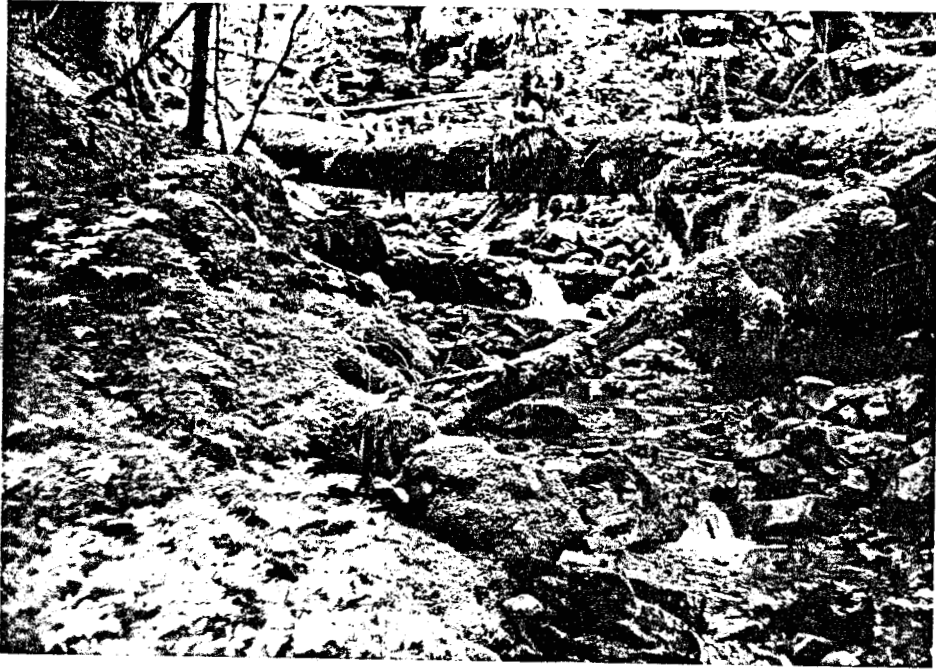
3. The gradient increases to 20% at the end of Section 1.

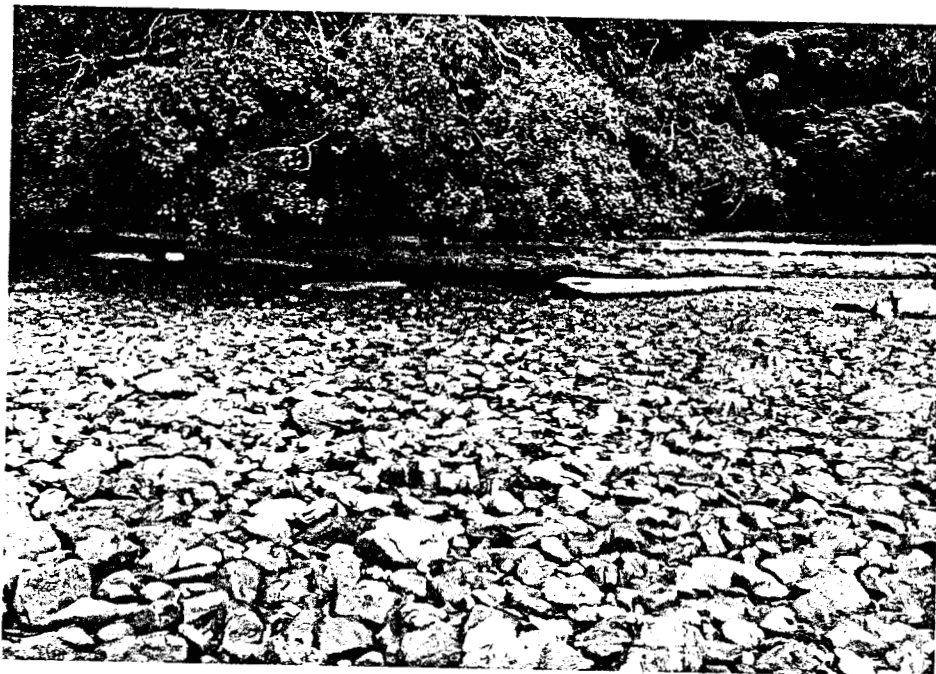
1. ITZ: no definite channel
